Re: Asbestos Dust Sampling Assessment for the project located at:
Pierce Hall First Floor University of California Riverside, California.

TAPE LIFT SAMPLE RESULTS AND LOCATION

Job ID/Site: 19-1132; Pierce Hall UCR

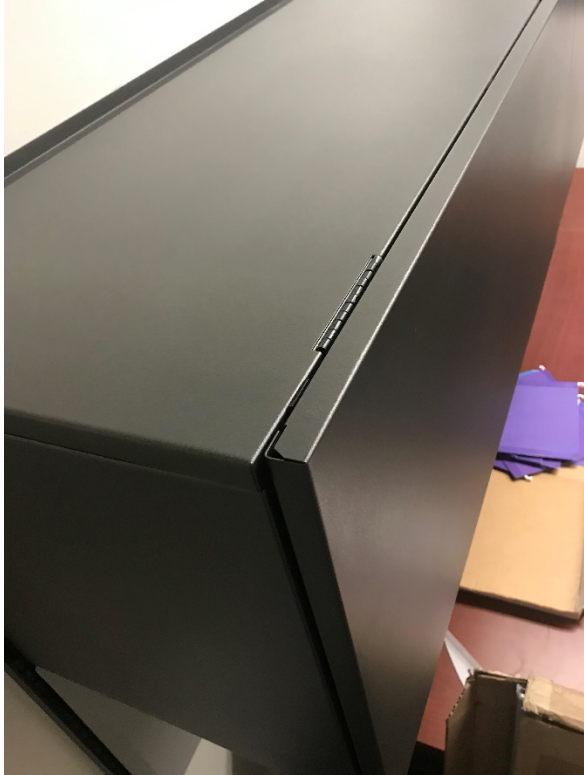
Sample #19 - Room 1144

| Sample ID | Lab Number | Asbestos Type | Percent in Layer | Asbestos Type | Percent in Layer | Asbestos Type | Percent in Layer |
|---|---|---|---|---|---|---|---|
| Layer: Black Mastic Debris | | Chrysotile | 2 % | | | | |
| Total Composite Values of Fibrous Components: | | Asbestos (Trace) | | | | | |

| SAMPLE NUMBER | SAMPLE LOCATION | MATERIAL DESCRIPTION | SQUARE FOOTAGE |
|---|---|---|---|
| 19 | 1144 UPPER CABINET | | |

Because there was detected levels of asbestos in one of the thirty settle tape lift dust samples obtained, Ambient recommends the settle dust within room 1144 upper cabinet be clean-up and decontamination per the following procedures.

The work activities should be performed by a California licensed abatement contractor with trained personnel. The designated work area should be off limits to unauthorized personnel during all clean up and decontamination procedures. All workers should be required to wear appropriate personal protective equipment during all asbestos cleanup and decontamination activities. Personal protective equipment utilized will include half face negative pressure respirators, full-bodied tyvek suite, boots and eye protectors. Each respirator should be equipped with HEPA filters.

All cleanup and decontaminate activities should be performed by the use of hand tools and HEPA filtered vacuumed (Proof of SCAQMD permits for all HEPA equipment will be on site during all asbestos related activities). Any waste generated during these activities should be placed into a DOT approved transparent 6-mil polyethylene bag, sealed then each waste bag should be placed into a second DOT approved transparent 6-mil polyethylene labeled bag for disposal as friable waste for disposal. All asbestos containing and/or contaminated debris should be kept wet during all aspects of these asbestos procedures. Upon completion of the work activities, final samples should be obtained. All final samples should have no asbestos contents prior to any release of the work area.
