## **Lessons Learned...Glass Vessel Explosion**

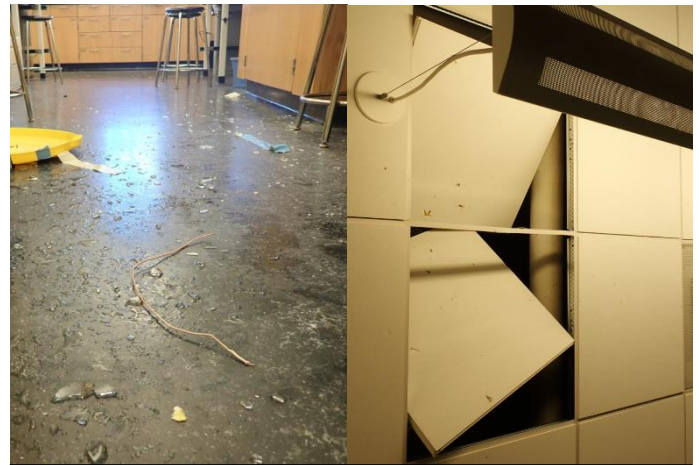
Students were doing an experiment involving compressed gas purging of a 20L glass vessel when the container overpressurized and burst. Broken glass and water were ejected across the lab space. Two students closest to the explosion were severely injured. Neither the students or the TA in charge were wearing safety glasses or goggles at the time of the explosion, and one student permanently lost sight in one eye from their injury.

*Glass and water were blown throughout the lab space. Enough force was generated to lift the tiles above the vessel.*

- Safety culture on PPE in laboratory spaces was inadequate and use by students or TAs was not enforced.
- Pressure vessel was not rated for pressures that could be achieved in experiment.
- No pressure relief devices in use.

- Experiment was permanently retired, and remaining experiments were reviewed before they were used again.
- Instructional lab safety program was developed to address responsibilities of all parties involved in the teaching laboratory environment.
- Department established improved PPE checks for teaching laboratories to improve compliance.
